Manhole Inspection Summary

Manhole # S21WW1019MH

Insp Date: **5/8/07 3:11 PM**

Location Address: **BOUTON GREEN CT**

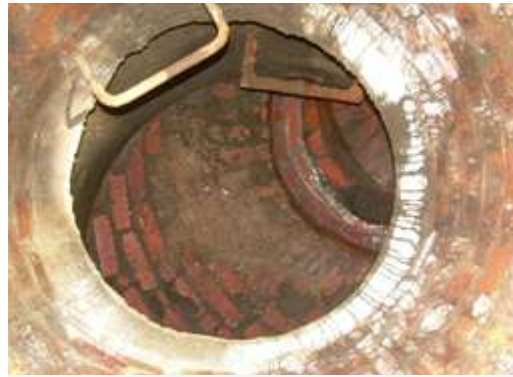
Top View

Corroded steps. Bench debris.

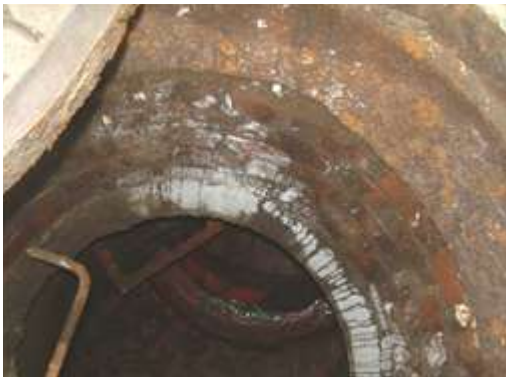
Defect

Frame leaks. Adjustment infiltration.
Corbel and Barrel infiltration.

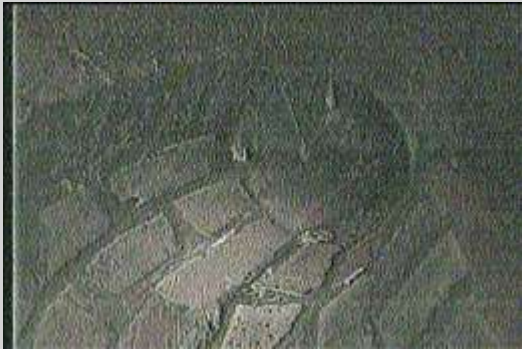
8 in. Circular Gravity Sewer Pipe Out @ 12 O'Clock

Infiltration: **None** Pipe Seal Cond: **Unknown**

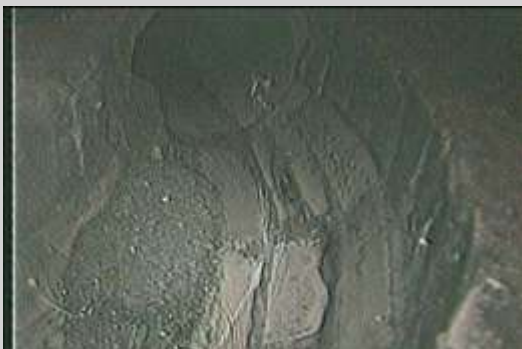
8 in. Circular Gravity Sewer Pipe In @ 3 O'Clock

Channel root intrusion.

Infiltration: **None** Pipe Seal Cond: **Roots**
